Manhole Inspection Summary

Manhole # S31EE2015MH

Location Address: **5709 SAINT ALBANS WAY**

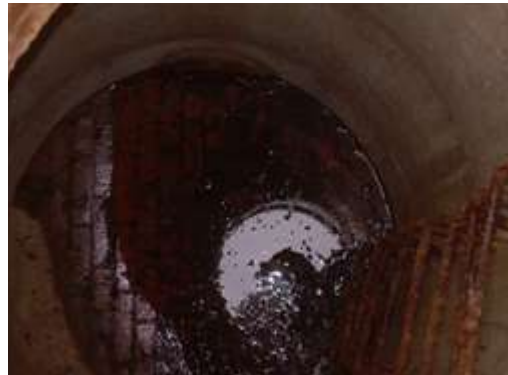
Top View

Corroded steps.

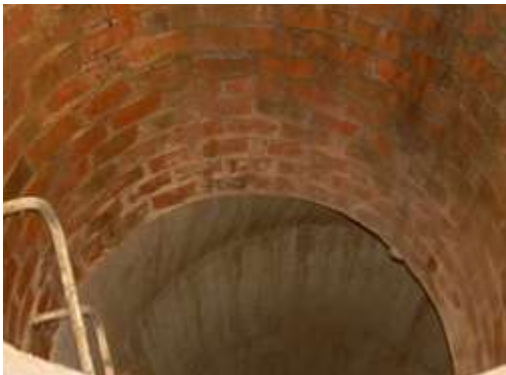
Defect

Adjustment and Corbel infiltration.

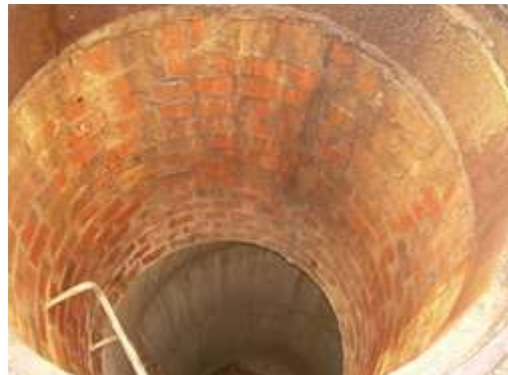
Defect

Frame leaks. Adjustment and Corbel infiltration.

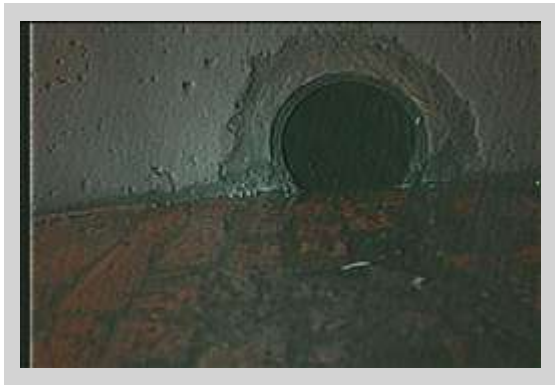
8 in. Circular Gravity Sewer
Pipe Out @ 12 O'Clock

Infiltration: **Evidence** Pipe Seal Cond: **Unknown**
